**MASS WASTING IN THE
FARGO-MOORHEAD REGION:**

**CASE STUDY #4:
THE TROUBLE WITH
ELM STREET**

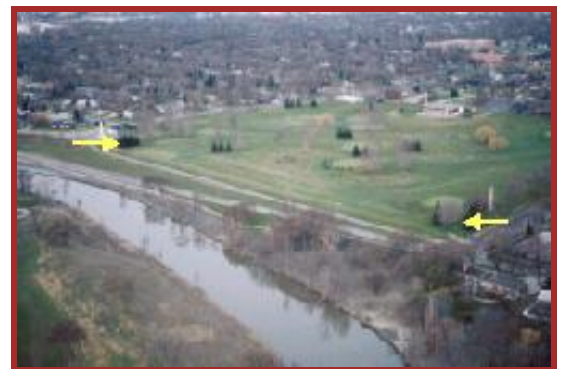
Elm Street at El Zagal Golf Course (1996). Dike is indicated by arrows. View is to the southwest.

While perhaps resolving the problem of golf course flooding, the dike has served to accelerate damage to the lands just east of it, including Elm Street. The weight of this massive dike squeezes the weak, underlying clays, forcing clay flow toward the river. This flow induces rifting of the land surface, causing severe damage to Elm Street and adjacent bike paths. As the dike squeezes downward, a major sag has developed in its central region.

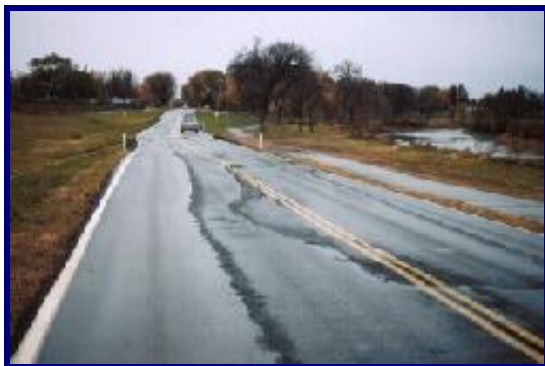
Rifted and uneven pavement of Elm Street. View is facing north toward intersection with 15th Ave. N. (1996). The dike is visible to the left of the photo.

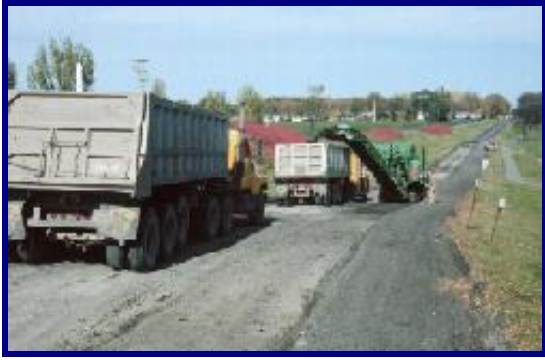
Repair to Elm Street, October 6, 1992. View to toward the north.

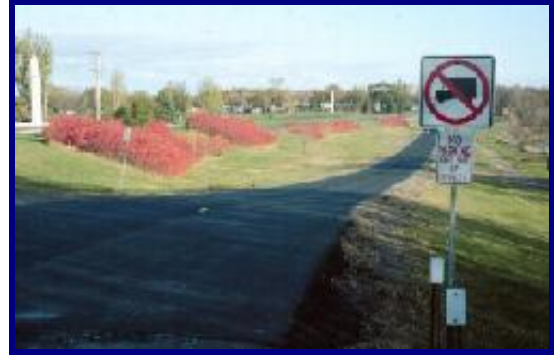
Completion of repaving of Elm Street, October 9, 1992. View is toward the north.

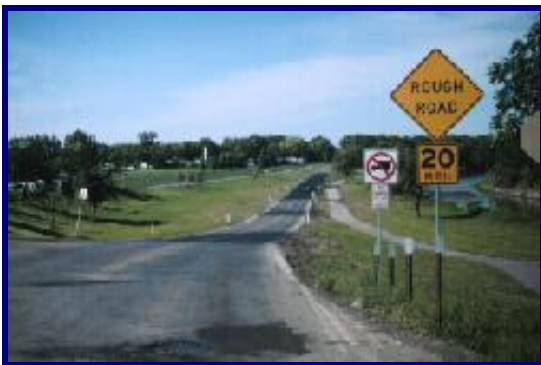
Pavement patches to remediate recent rifting are apparent in this photo taken in August, 1997. View is toward the north.
